## Solid Non-Hazardous Waste Disposal Site Inspection Report

<b>Client:</b>	The Corporation of the Municipality of Southwest Middlesex Mailing Address: 153 McKellar St, Post Office Box, 218, Glencoe, Ontario, Canada, N0L 1M0 Physical Address: 153 McKellar St, Southwest Middlesex, Municipality, County of Middlesex, Ontario, Canada, N0L 1M0 Telephone: (519)287-2015, FAX: (519)287-2359, email: jfrancisco@southwestmiddlesex.ca Client #: 2308-4XUQEP, Client Type: Municipal Government, NAICS: 913910		
<b>Inspection Site Address:</b>	Limerick Road Landfill (Mosa Landfill) Address: Lot: 23, Concession: 3, Geographic Township: MOSA, Southwest Middlesex, Municipality, County of Middlesex District Office: London - District GeoReference: Map Datum: NAD83, Zone: 17, Accuracy Estimate: 10-30 metres eg. Medium Quality GPS, Method: GPS, UTM Easting: 431559, UTM Northing: 4724065, , LIO GeoReference: Zone: , UTM Easting: , UTM Northing: , Latitude: 42.6661, Longitude: -81.8336 Site #: 6536-62NRPU

On December 7, 2016, a solid non-hazardous waste disposal site inspection was carried out by Environmental Officer Krysta-Leigh Johnston at the Limerick Road Landfill. The landfill is located on Lot 23,

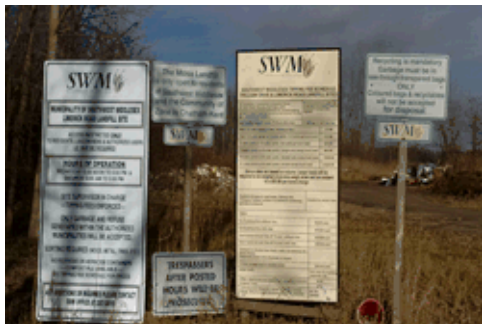
The site is fenced and secured by a gate. When open, the site is supervised by a municipal staff member. Signage at the entrance includes hours of operations, approved and unapproved wastes, tipping fees and contact information for the Municipality.

Signage at the landfill entrance

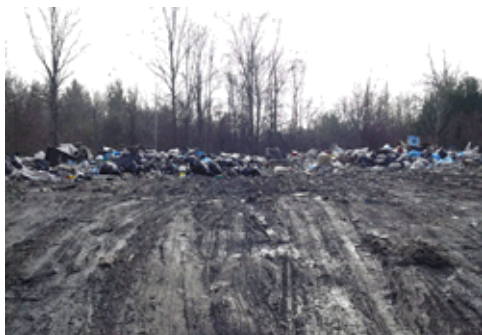
There are no specific requirements for cover material identified on the approval. On the day of the inspection, the area being used for waste tipping was relatively small with soil coverage on the access ramp. Cover material is applied once every two to three weeks, depending on how much waste is received. Cover material is dirt that either originates from the site, or is brought in by road crews digging ditches.

Heavy vegetation surrounding the active landfill has prevented litter from moving off-site. Well worn animal trails were found throughout the landfill, indicating that a pest population is present.

Active landfill area

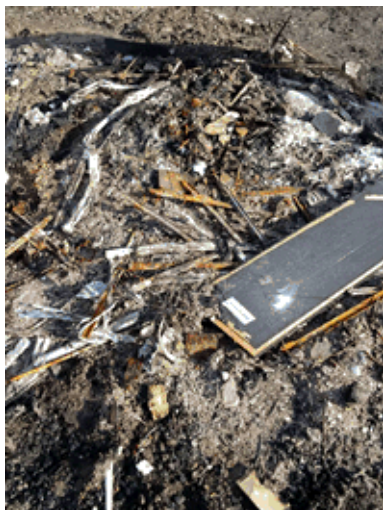
A relatively small burning pile was noted toward the north end of the landfill. There were metal pieces in the burn pile, much of which looked as though it belonged to furniture with metal braces or fixtures. Miscellaneous other pieces of metal (i.e. metal safety inserts for boots) were also noted in the pile. The site supervisor informed us that furniture is no longer burned, but crushed and buried in the landfill. The Municipality is reminded to ensure that only clean wood and brush is burned at the landfill.

Metal in the burn pile

Metal in the burn pile suggests that materials other than clean wood and brush are still being burned at the landfill. While measures have been put in place to dispose of materials appropriately, the Municipality is reminded that only clean wood and brush can be burned.

During the inspection, metal was found in the small burn pile in the north end of the landfill. This would suggest that Mosa / Limerick Road Landfill has not fully met its requirements for the burning of clean wood and brush. Burning at the landfill shall not include any Municipal waste as defined by Regulation 347.

1. The Corporation of the Municipality of Southwest Middlesex shall ensure that only clean wood and brush are burned at Limerick Road Landfill. The Municipality shall confirm that they are following their burning procedure by January 30, 2017. Confirmation can be made by email or letter at :

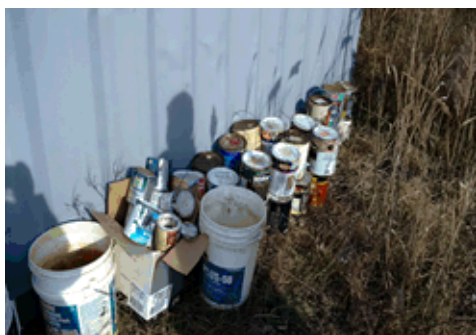
Paint cans were observed during the inspection. The site supervisor stated that these were dumped at the entrance to the landfill, and that cans with remaining paint would be brought into Lowe's for disposal. The landfill does not currently accept household hazardous wastes.

Paint cans stockpile
