Solid Non-Hazardous Waste Disposal Site Inspection Report

Client:	The Corporation of the Municipality of Southwest Middlesex Mailing Address: 153 McKellar St, Post Office Box, 218, Glencoe, Ontario, Canada, N0L 1M0 Physical Address: 153 McKellar St, Southwest Middlesex, Municipality, County of Middlesex, Ontario, Canada, N0L 1M0 Telephone: (519)287-2015, FAX: (519)287-2359, email: jfrancisco@southwestmiddlesex.ca Client #: 2308-4XUQEP, Client Type: Municipal Government, NAICS: 913910		
Inspection Site Address:	Limerick Road Landfill (Mosa Landfill) Address: Lot: 23, Concession: 3, Geographic Township: MOSA, Southwest Middlesex, Municipality, County of Middlesex District Office: London - District GeoReference: Map Datum: NAD83, Zone: 17, Accuracy Estimate: 10-30 metres eg. Medium Quality GPS, Method: GPS, UTM Easting: 431559, UTM Northing: 4724065, , LIO GeoReference: Zone: , UTM Easting: , UTM Northing: , Latitude: 42.6661, Longitude: -81.8336 Site #: 6536-62NRPU

On January 11, 2018 a solid non-hazardous waste disposal site inspection was conducted by Nicole Does at the Limerick Road Landfill, located on Lot 23, Concession 3, in the Municipality of Southwest Middlesex. The inspec

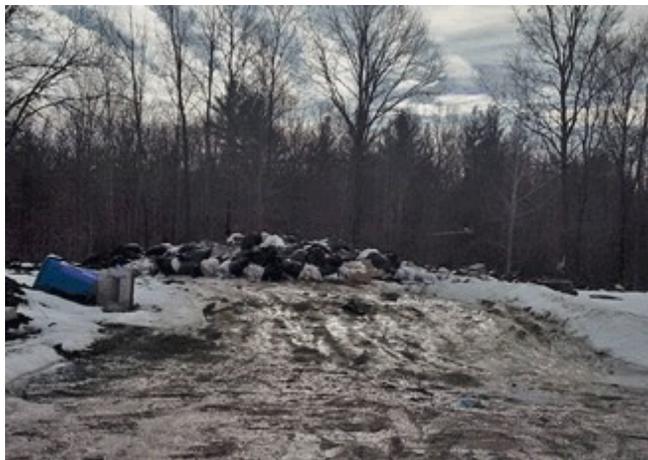
Ms. Clayton stated that cover is now being used on an as-needed basis. Cover material was piled beside the active cell and is re-stocked every 12 weeks by Public Works. During the inspection, the active waste cell was uncovered. A cat was observed around the waste, and there was evidence of animal trails around/through the waste. Ms. Clayton acknowledged the presence of a rat population as well.

Active waste cell during inspection

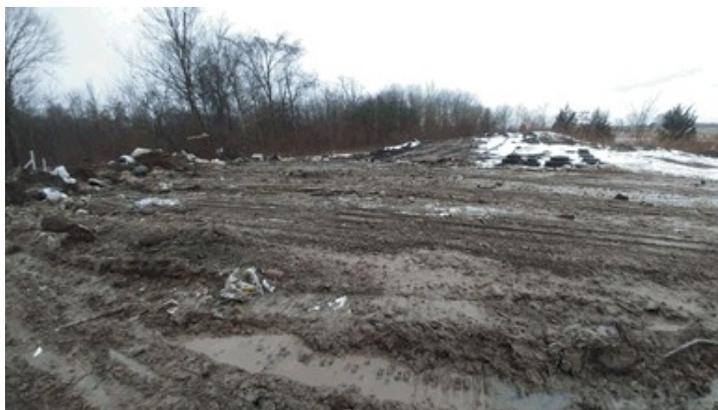
On Friday January 12th, an email was received from Mr. Sholdice stating that he had pushed and covered all exposed waste approximately a few hours after the inspection. He mentioned that waste is generally covered within 24 hours after the landfill has been open.

Active waste cell later that afternoon (pushed and covered). Picture taken and sent by Mr. Sholdice

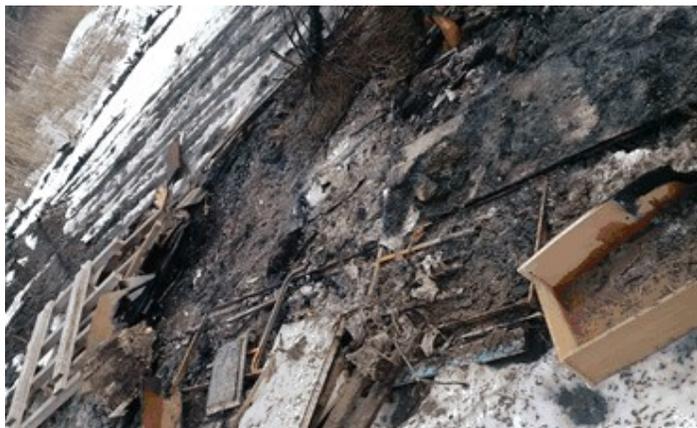
Condition 2 in the Certificate of Approval states that no burning of municipal waste is permitted. Burning still takes place at the site on an as-needed basis. During the inspection, there was evidence of burning other than clean wood and brush. Observed were the remains of wood furniture, door knobs, table frame/legs, other pressure treated wood, cans and other unidentifiable debris. The burning of waste other than clean wood and brush has been an ongoing issue communicated in past MOECC inspection reports in 2016, 2014 and 2004. The municipality is reminded that these materials do not meet the criteria for "clean wood and brush".

Evidence of burning.

Evidence of waste other than clean wood and brush was observed to have been burned on-site, including:
-tables, doors and other wood furniture
-pressure treated wood
-cans and other unidentifiable debris

1. The Corporation of the Municipality of Southwest Middlesex must ensure that only clean wood and brush are burned at the Limerick Landfill. Confirmation of this must be sent to the undersigned Officer, with a signature from the Publics Works Manager as well as the Site Attendant, Mike Sholdice. Confirmation must be made by email or letter, no later than February 9, 2018.
2. The Corporation of the Municipality of Southwest Middlesex must keep John McGlynn (Area Environmental Officer) informed on all decisions regarding the operations the Limerick Landfill. This includes but is not limited to submitting the final Operations Review no later than 7 days after receiving it.

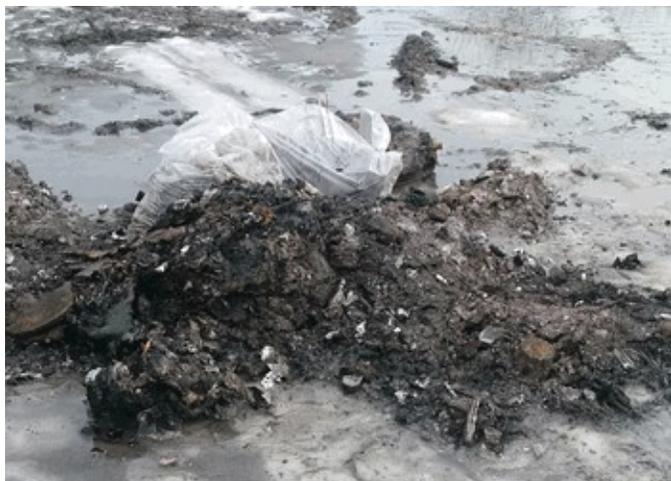
Mr. Sholdice stated that these plastic bags contained only weeds, ashes and pine tree needles, and that the burn pile in this picture are ashes dumped from barrels brought by residents.
