Structure Name	B101		
Main Hwy/Road #	Pratt Siding Road	On <input checked="" type="checkbox"/> Under <input type="checkbox"/>	Crossing Type: Navig. Water <input type="checkbox"/> Non-Navig. <input checked="" type="checkbox"/> Ped. <input type="checkbox"/> Road <input type="checkbox"/> Other <input type="checkbox"/>
Structure Location	Intersection of Carolinian Road and Pratt Siding Road Lot 8&9 Con. 8		
Latitude	4736274.9	Longitude	432005.6
Owners	Mun. of Southwest Middlesex	Heritage Designation	Not Consid: <input checked="" type="checkbox"/> Cons/not App. <input type="checkbox"/> List/n.d. <input type="checkbox"/> Designation Design./not list <input type="checkbox"/> Desig & List <input type="checkbox"/>
MTO region	South-Western	Road Class:	Freeway <input type="checkbox"/> Arterial <input type="checkbox"/> Collector <input type="checkbox"/> Local <input checked="" type="checkbox"/>
MTO District	2	Posted Speed	No. of Lanes 2

Structure Name	B102		
Main Hwy/Road #	Conservation Road	On <input checked="" type="checkbox"/> Under <input type="checkbox"/>	Crossing Type: Navig. Water <input type="checkbox"/> Rail <input type="checkbox"/> Non-Navig. <input type="checkbox"/> Road <input typ

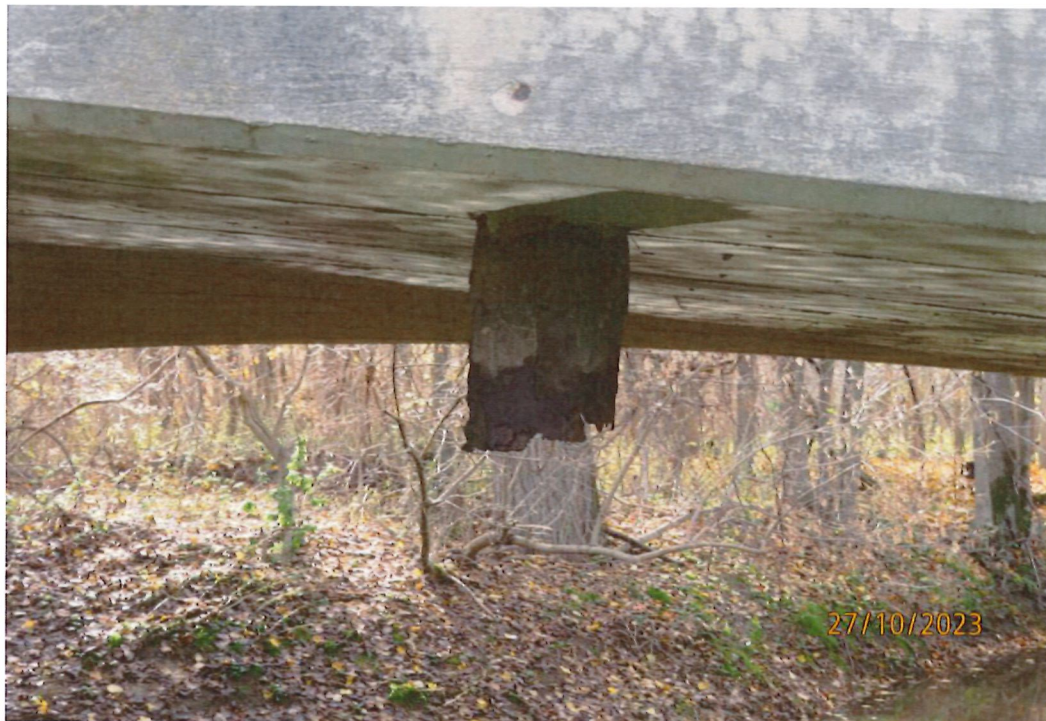
Element Group:	Drainage Systems		Length:			
Element Name:	Deck Drains		Width:			
Location:			Height:			
Material:	Steel		Count:			
Element Type:			Total Quantity:	4		
Environment:	severe		Not Inspected:			
Protection System:	none					Perform. Maint.
Condition	Units	Exc.	Good	Fair	Poor	Deficiencies Needs
Data:	sq. m / m / each / % / all				all	
<b>Comments:</b> Drains are rusted, not functioning and need to be relined.						
<b>Recommended Work:</b> None: <input type="text"/> 1 - 5 years <input type="text"/> <1 year <input type="text"/> x						
Urgent: <input type="text"/>

**View of Deck Drains**

Repair Rehabilitation Required		Priority			Estimated Construction Cost
Element	Repair and Rehabilitation Required	1 to 5 years	Within 1 year	Urgent	
Deck Drains	Reline with P.V.C.	x			10000
Total Cost					\$10,000

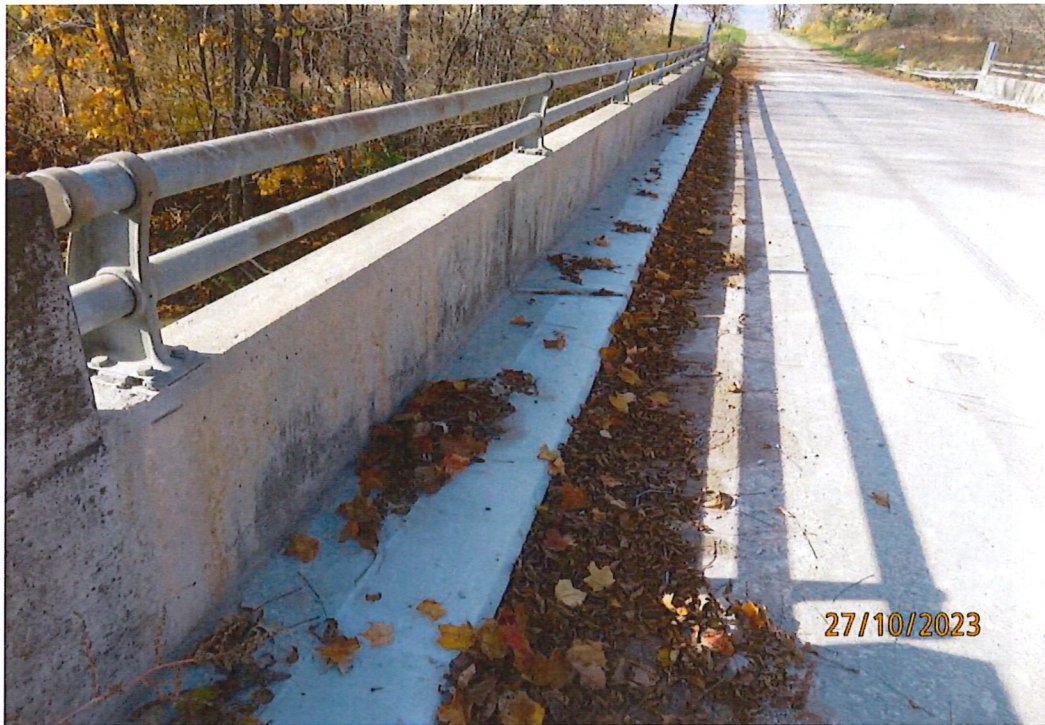
Deck top and curbs rehabilitated in 2022 / 2023

**View of Repaired Deck and Curb**

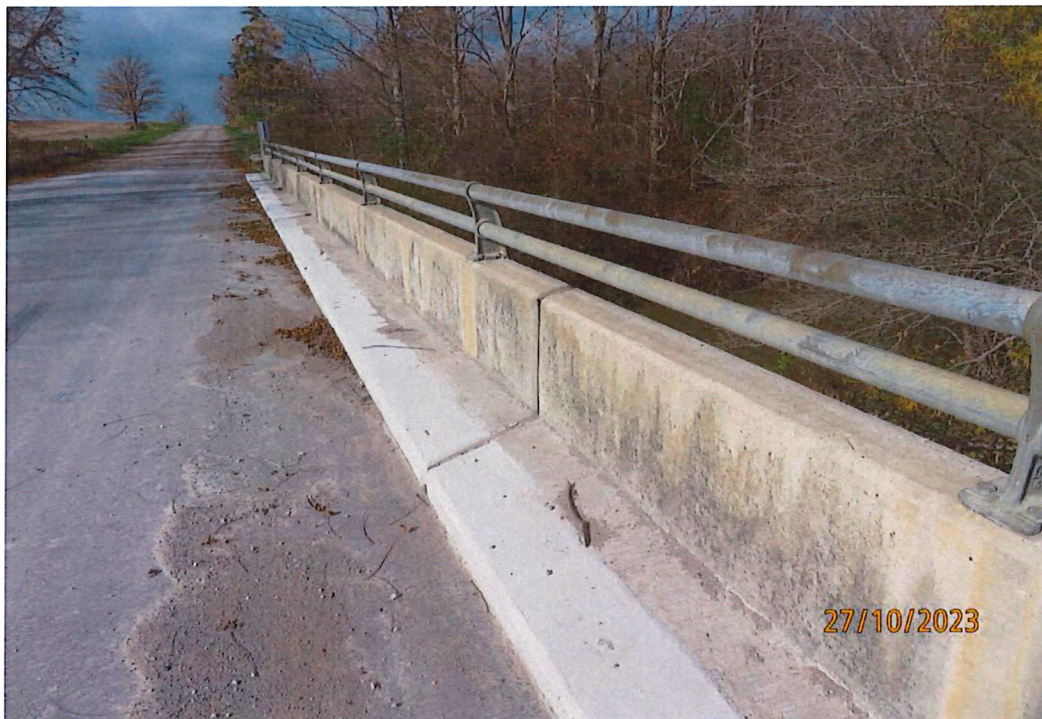
**Alternate View of Repaired Deck and Curb**

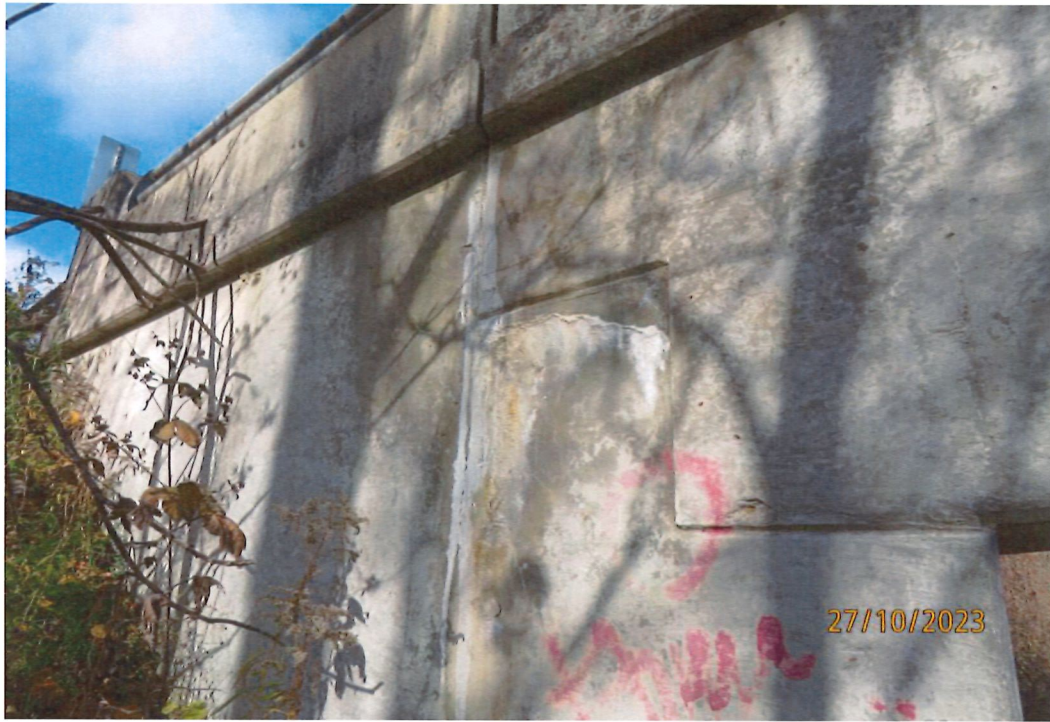
Element Group:	Abutments	Length:	
Element Name:	Abutment Walls	Width:	9.72
Location:		Height:	
Material:	Cast in Place Concrete	Count:	
Element Type:		Total Quantity:	2
Environment:	Benign	Not Inspected:	
Protection System:	none		
Condition	Units	Exc.	Good
Data:	sq. m / m / each / % / all		remaining
		Fair	Poor
		Perform.	Maint.
		Deficiencies	Needs
Comments:			
Efflorescence present on northwest corner			
Recommended Work:			
None:		x	1 - 5 years
Urgent:			<1 year

**Efflorescence on Northwest Corner**

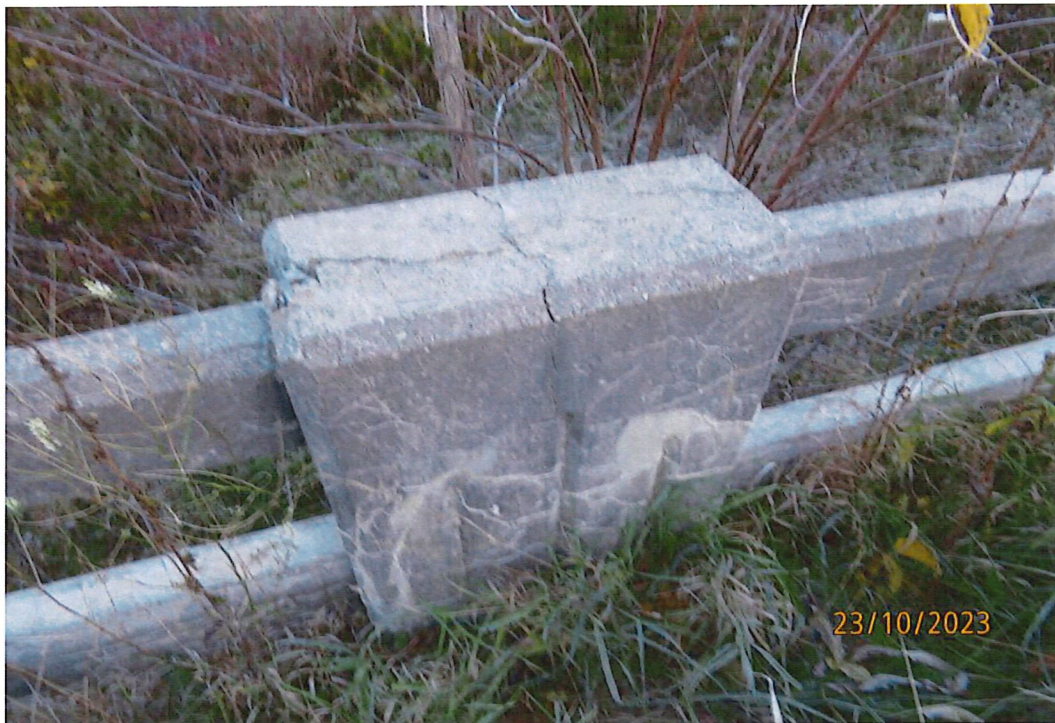
**Concrete Deterioration on South Side**

Repair Rehabilitation Required		Priority			Estimated Construction Cost
Element	Repair and Rehabilitation Required	1 to 5 years	Within 1 year	Urgent	
Abutments	Concrete repairs	x			84000  28000 (for all concrete repairs)
Barriers	Carry flex beam across structure on existing	x			
	Concrete barriers	x			
Railings	Concrete repairs	x			
	* 8 square meters of concrete needs to be repaired on bridge.				
Total Cost					\$112,000

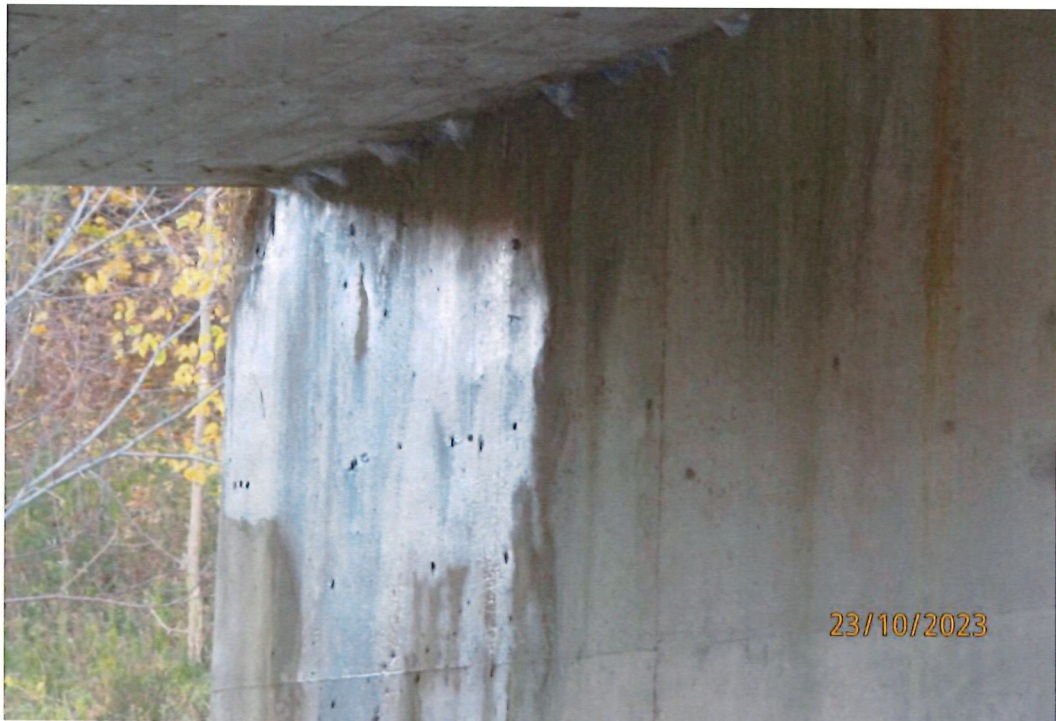
**View of Concrete Deterioration on Underside of Bridge**

Element Group:	Decks	Length:	7.3				
Element Name:	Soffit	Width:	8.4				
Location:		Height:					
Material:	Concrete	Count:					
Element Type:	Cast in Place	Total Quantity:					
Environment:	Severe	Not Inspected:					
Protection System:	none					Perform.	Maint.
Condition	Units	Exc.	Good	Fair	Poor	Deficiencies	Needs
Data:	sq. m / m / each / % / all		all				
Comments:							
Concrete deterioration is present							
Recommended Work:							
	None:	<div style="border: 1px solid black; width: 40px; text-align: center;">x</div>	1 - 5 years	<div style="border: 1px solid black; width: 60px;"></div>	<1 year	<div style="border: 1px solid black; width: 60px;"></div>	
	Urgent:	<div style="border: 1px solid black; width: 40px;"></div>					
Repair concrete

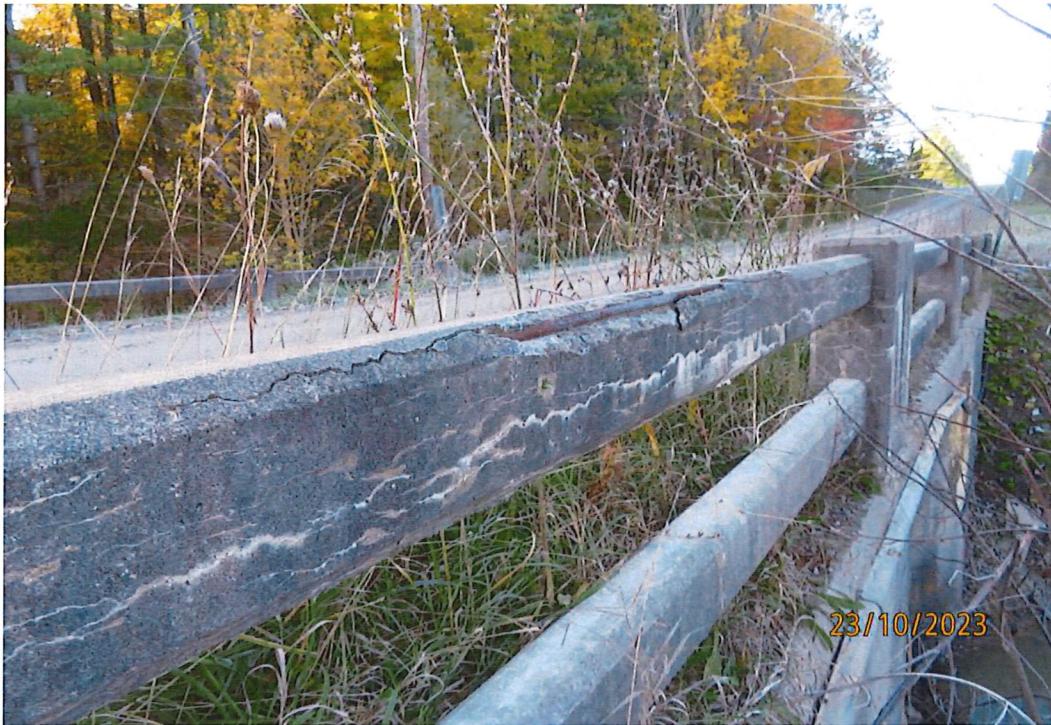
**Deterioration on Railings on North Side**

Element Group:	Barriers	Length:	15.9					
Element Name:	Barrier Wall	Width:						
Location:		Height:						
Material:	Concrete	Count:	2					
Element Type:	Cast in place	Total Quantity:						
Environment:	Severe	Not Inspected:						
Protection System:	none						Perform.	Maint.
<b>Condition</b>	Units	Exc.	Good	Fair	Poor		Deficiencies	Needs
<b>Data:</b>	sq. m / m / each / % / all			all				
<b>Comments:</b>								
Should be updated, some efflorescence on south barrier								
<b>Recommended Work:</b>								
None:		<input style="width: 50px;" type="text"/>	1 - 5 years	<input style="width: 50px; text-align: center;" type="text" value="x"/>	<1 year	<input style="width: 50px;" type="text"/>		
Urgent:		<input style="width: 50px;" type="text"/>						
Upgrade in conjunction with repairs

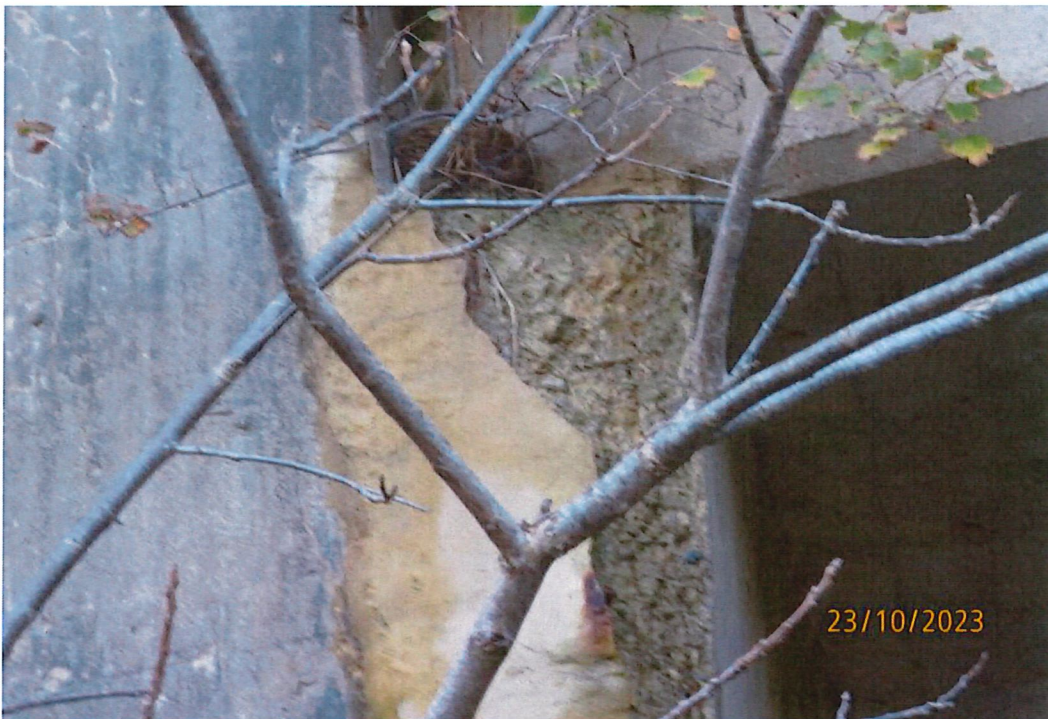
**Concrete Deterioration on North Side**

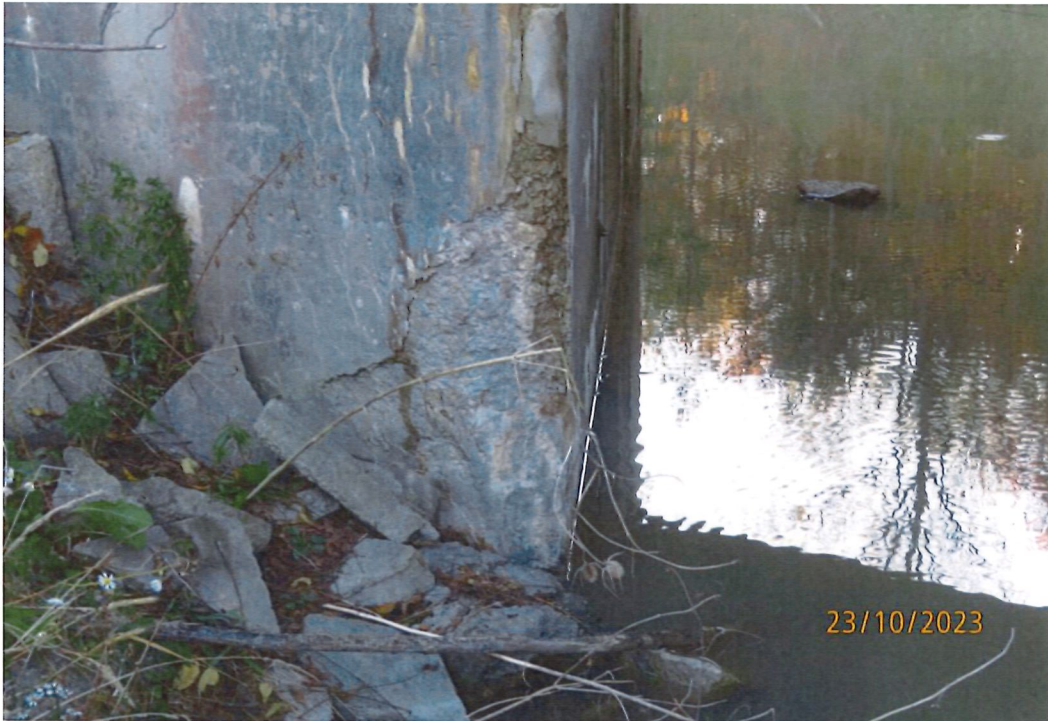
**Concrete Deterioration on North Abutment Base**

Element Group:	Abutments	Length:					
Element Name:	Abutment Walls	Width:					
Location:		Height:					
Material:	Cast in Place Concrete	Count:	2				
Element Type:		Total Quantity:					
Environment:	Benign	Not Inspected:					
Protection System:							Perform.    Maint.
<b>Condition</b>	Units	Exc.	Good	Fair	Poor	Deficiencies	Needs
<b>Data:</b>	sq. m / m / each / % / all			all			
<b>Comments:</b>							
Corner of beam seat chipped, has caused efflorescence over last 30 years and subsequent deterioration.							
<b>Recommended Work:</b>	None:		1 - 5 years	x	<1 year		
	Urgent:						
Repair concrete.

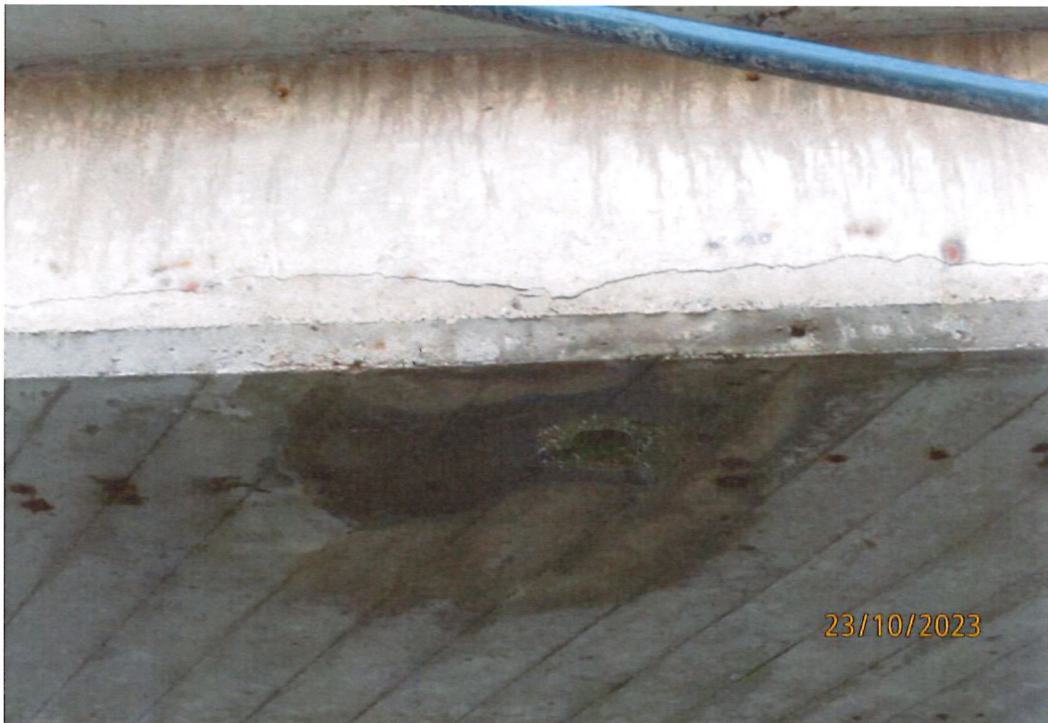
**Concrete Deterioration on North Soffit**

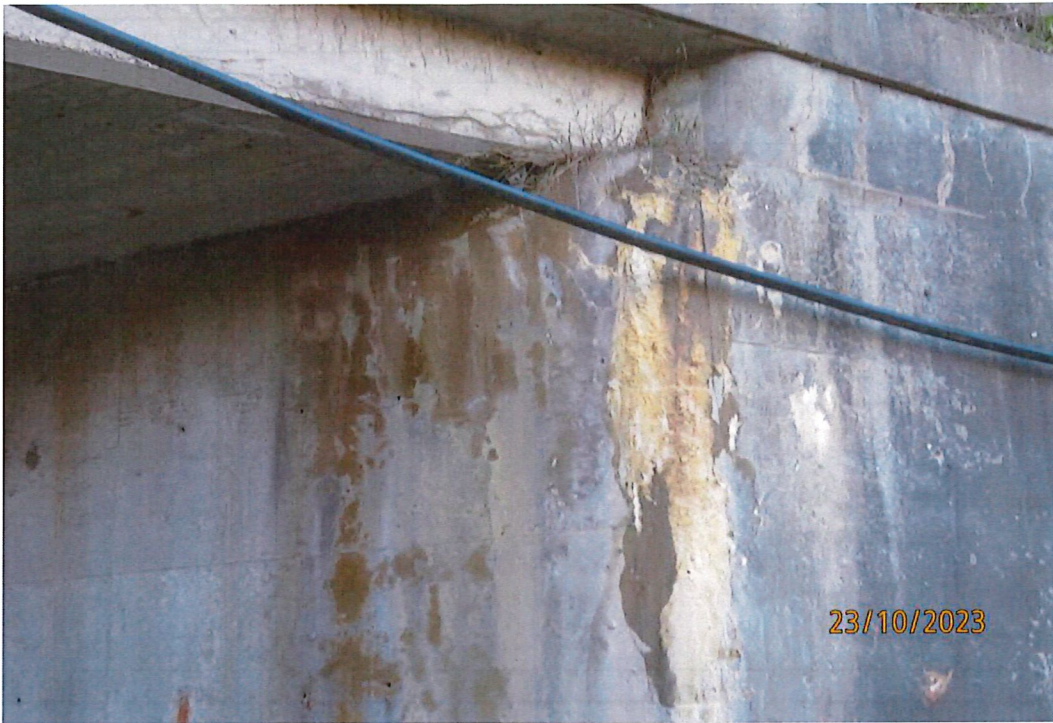
**Efflorescence on North Side**
