Structure Name	<input type="text" value="C110"/>		
Main Hwy/Road #	<input type="text" value="CPR Drive"/>	On <input checked="" type="checkbox"/> Under <input type="checkbox"/>	Crossing Type: Navig. Water <input type="checkbox"/> Rail <input type="checkbox"/> Non-Navig. Road <input type="checkbox"/> Ped. <input checked="" type="checkbox"/> Other <input type="checkbox"/>
Structure Location	<input type="text" value="1.0km West of DunDonald Road Lot 2 Con. 3&4"/>		
Latitude	<input type="text" value="4734168.3"/>	Longitude	<input type="text" value="439398.7"/>
Owners	<input type="text" value="Mun. of Southwest Middlesex"/>	Heritage Designation	Not Consid: <input checked="" type="checkbox"/> Cons/nt. App. <input type="checkbox"/> List/n.d. <input type="checkbox"/> Desig./not list <input type="checkbox"/> Desig & List <input type="checkbox"/>
MTO region	<input type="text" value="South-Western"/>	Road Class:	Freeway <input type="checkbox"/> Arterial <input type="checkbox"/> Collector <input checked="" type="checkbox"/> Local <input type="checkbox"/>

Date of Inspection:	October. 27, 2023
Inspector:	B. Widner
Others in Party:	
Equipment Used:	
Weather:	sunny
Temperature:	20 degrees celsius

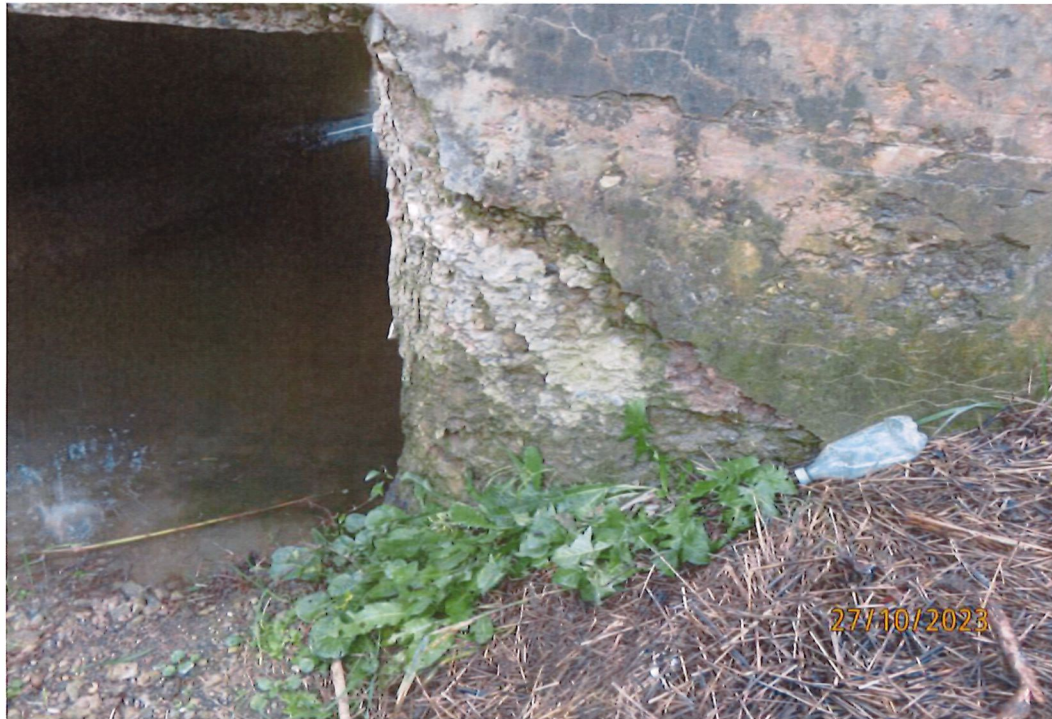
Element Group:	Outlet Components	Length:	7.9		
Element Name:	Wingwalls & Headwalls	Width:	0.3		
Location:		Height:			
Material:	Concrete	Count:			
Element Type:	Broken Concrete	Total Quantity:			
Environment:		Not Inspected:			
Protection System:					Perform. Maint.
Condition	Units	Exc.	Good	Fair	Poor
Data:	sq. m / m / each / % / all			all	
Comments: Some concrete deterioration - repair (see photo)					
Recommended Work: None: <input type="text"/> 1 - 5 years <input checked="" type="text"/> <1 year <input type="text"/> Urgent: <input type="text"/>

Concrete Deterioration on Outlet Side

Repair Rehabilitation Required		Priority			Estimated Construction Cost
Element	Repair and Rehabilitation Required	1 to 5 years	Within 1 year	Urgent	
Wingwalls, Headwalls... Curbs	Concrete Repairs	x			28000
Total Cost					\$28,000

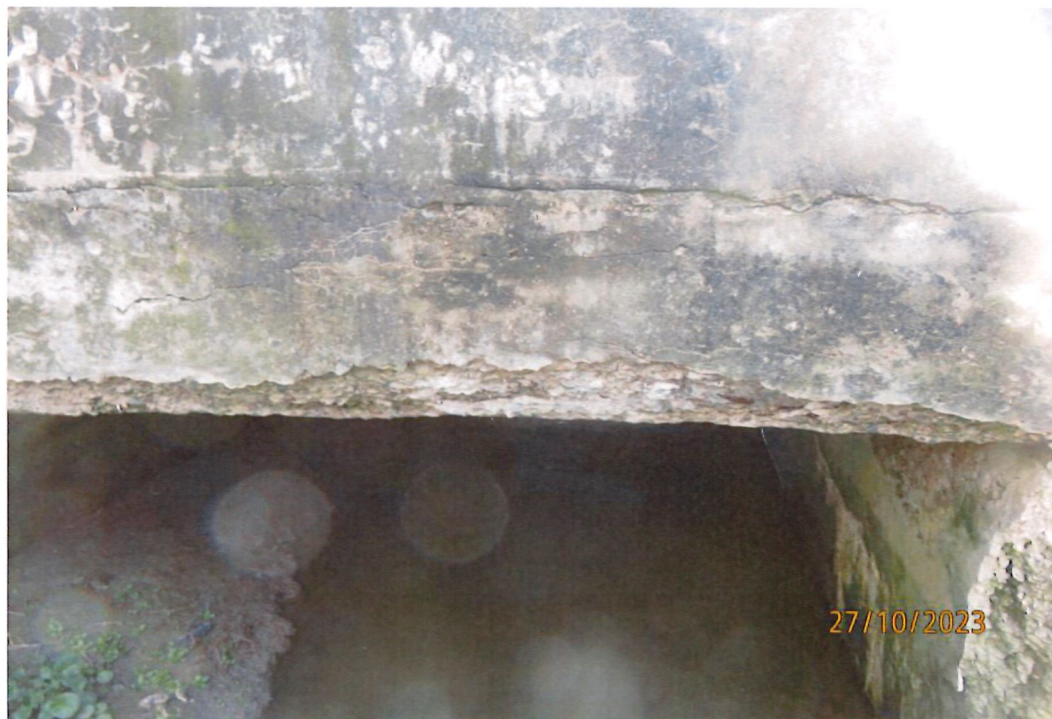
Concrete Deterioration on Outlet Side - Alternate View

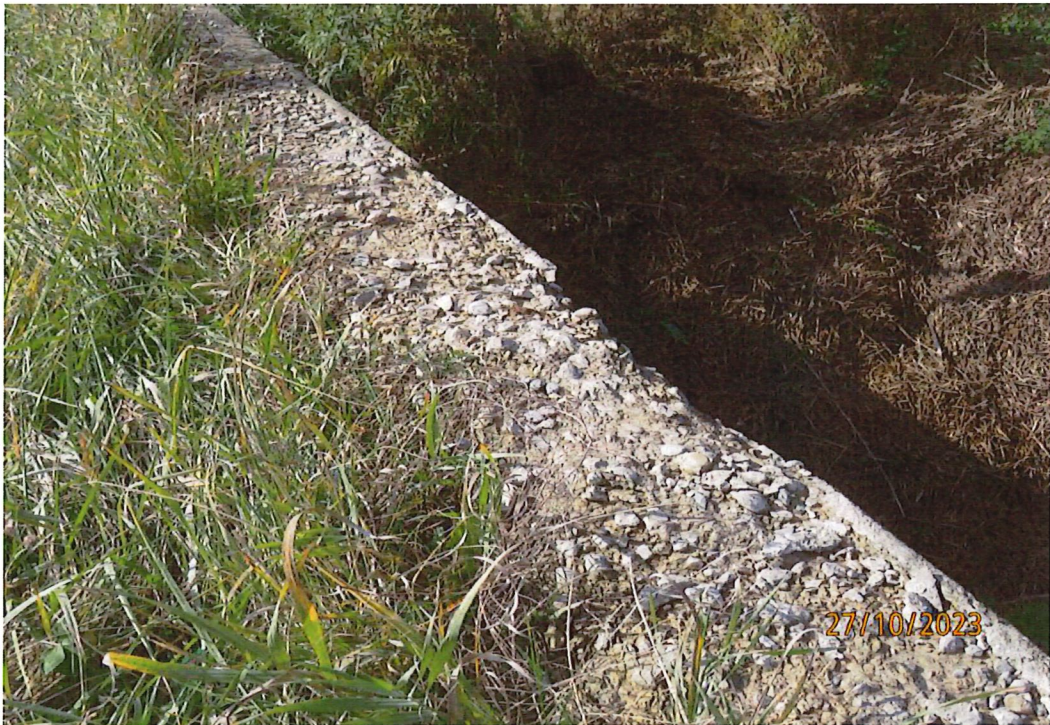
Concrete Deterioration on Top of Headwall

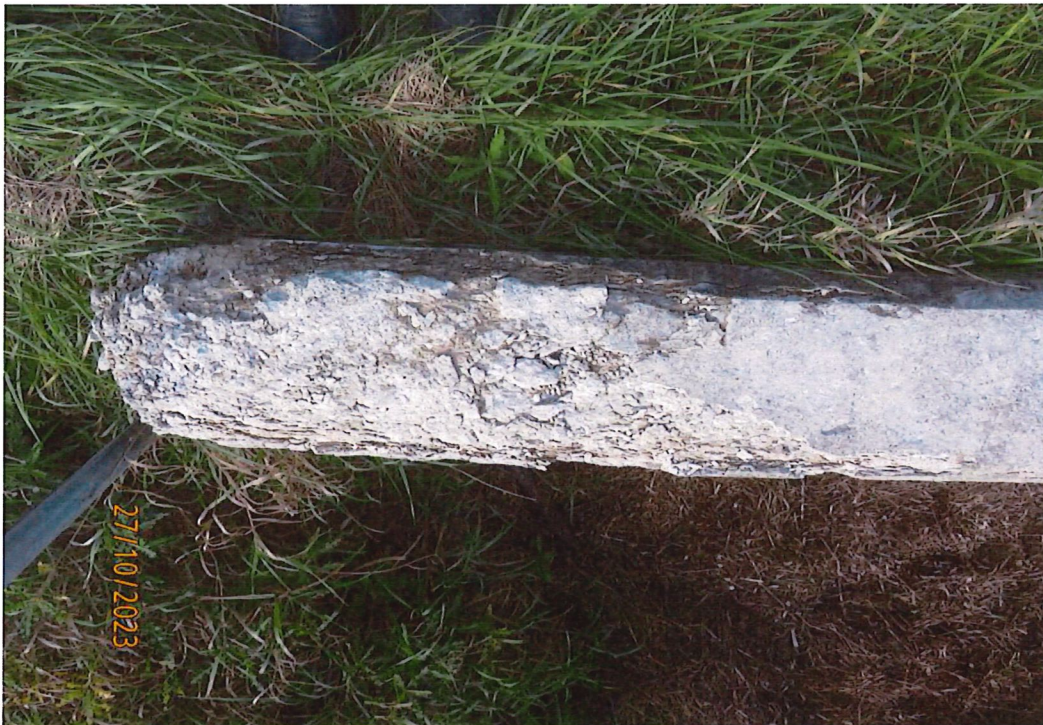
Concrete Deterioration on Southwest Corner

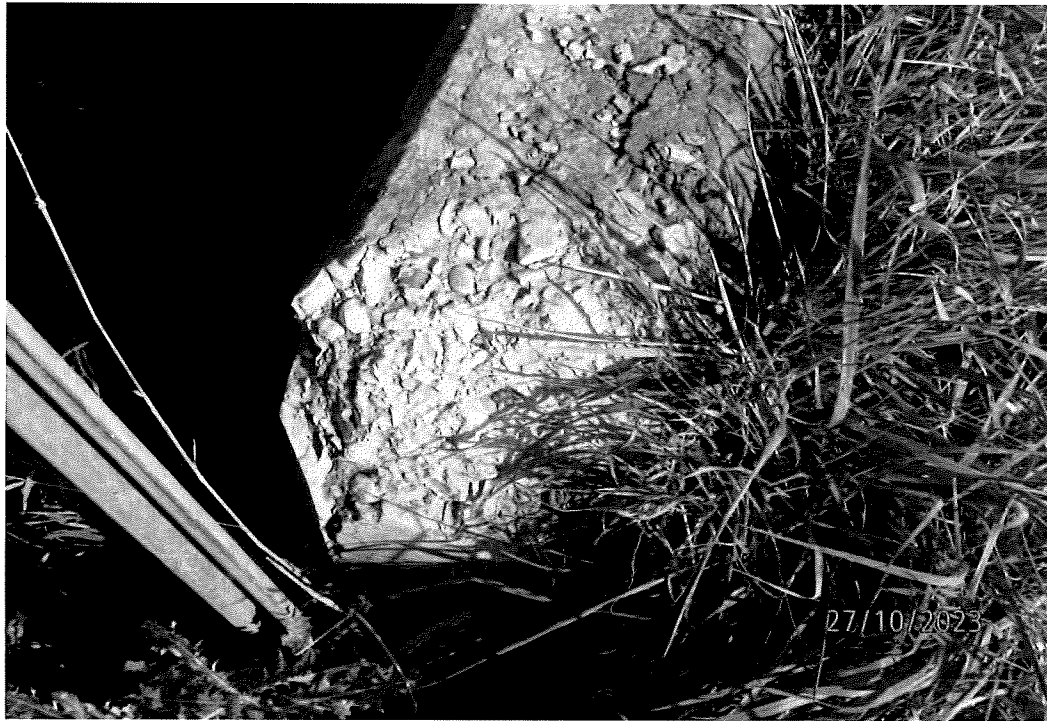
Concrete Deterioration on Norththwest Corner

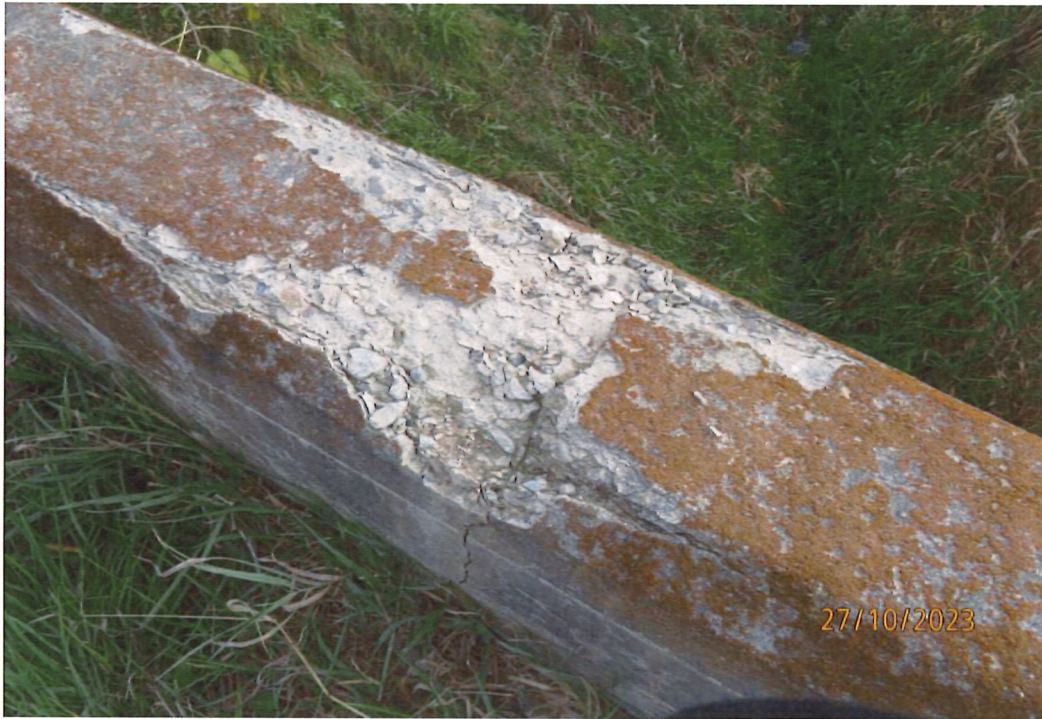
Concrete Deterioration

Repair Rehabilitation Required		Priority			Estimated Construction Cost
Element	Repair and Rehabilitation Required	1 to 5 years	Within 1 year	Urgent	
Signs	Straighten them to proper position	x			500
Structure	Some concrete deterioration on barrier walls - repair	x			10000
Total Cost					\$10,500

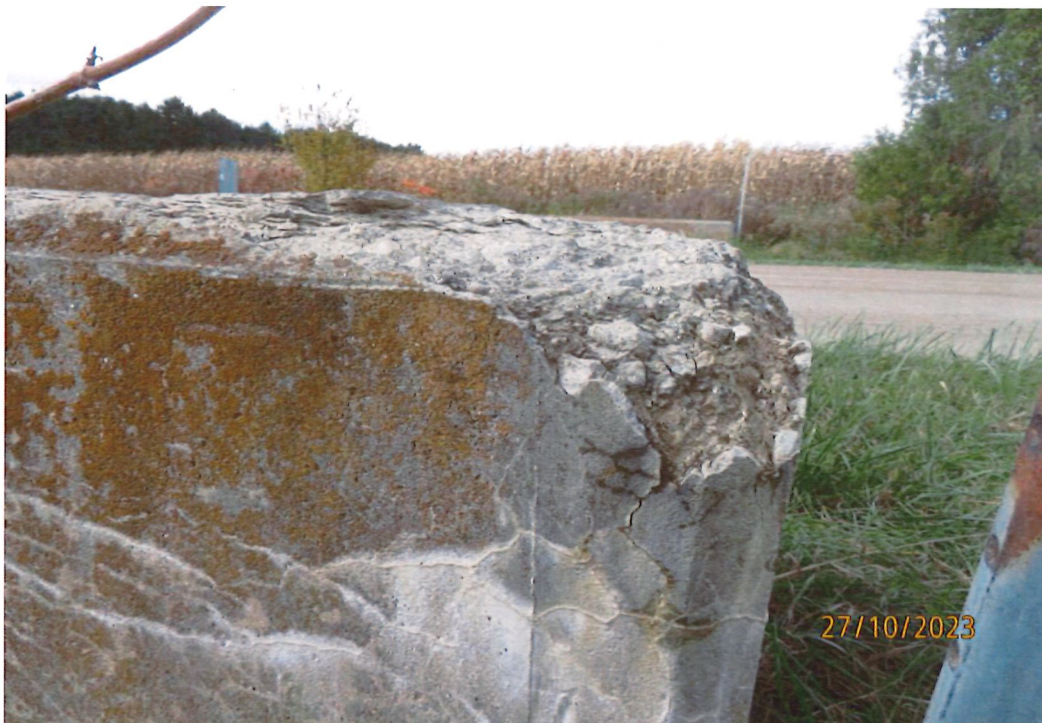
Concrete Deterioration - Alternate View

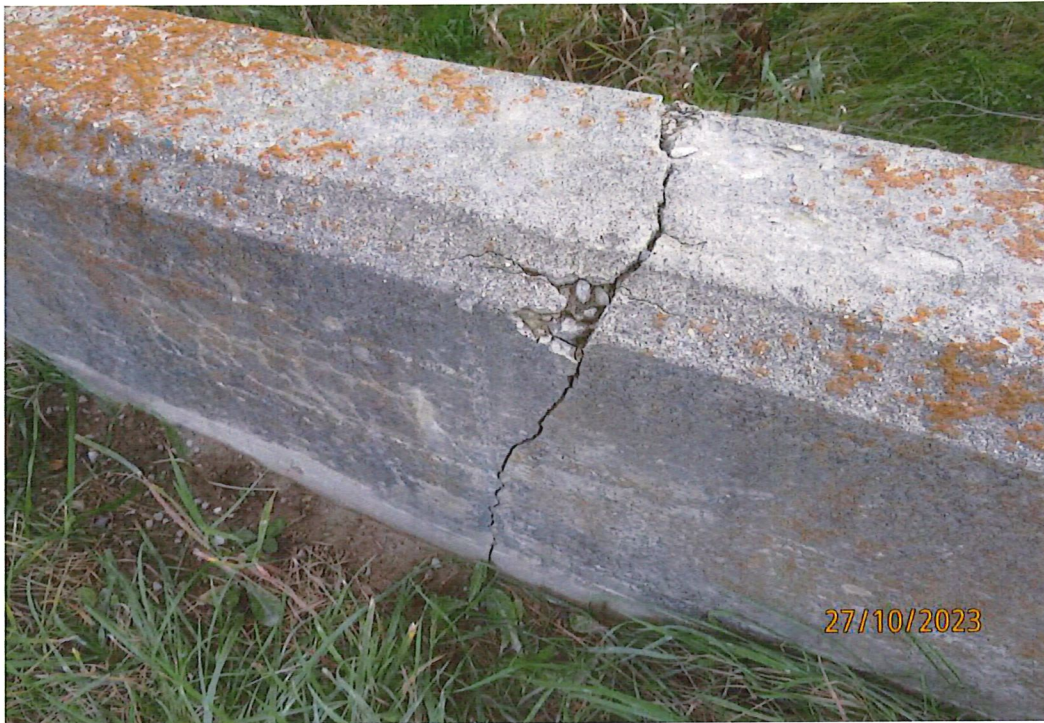
Element Group:		Inlet Components		Length:		7.7		
Element Name:		Wingwalls & Headwalls		Width:		0.3		
Location:				Height:				
Material:		Concrete		Count:				
Element Type:		Cast in Place		Total Quantity:				
Environment:				Not Inspected:				
Protection System:							Perform.	Maint.
Condition Data:	Units	Exc.	Good	Fair	Poor	Deficiencies	Needs	
	sq. m / m / each / % / all		all					
Comments: Minor deterioration on headwall								
Recommended Work:		None:	x	1 - 5 years		<1 year		
		Urgent:

Minor Cracking and Deterioration on South Headwall

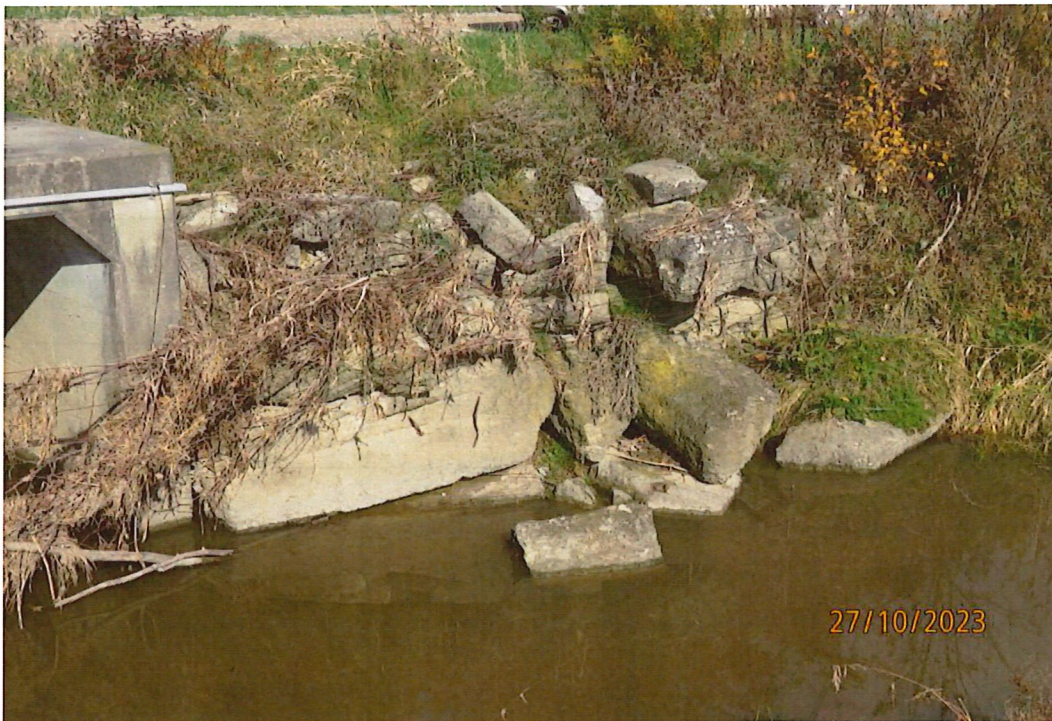
Wingwall Requiring Repair - Altenate View

Repair Rehabilitation Required		Priority			Estimated Construction Cost
Element	Repair and Rehabilitation Required	1 to 5 years	Within 1 year	Urgent	
Wingwalls	Repair all wingwalls	x			28000
Total Cost					\$28,000

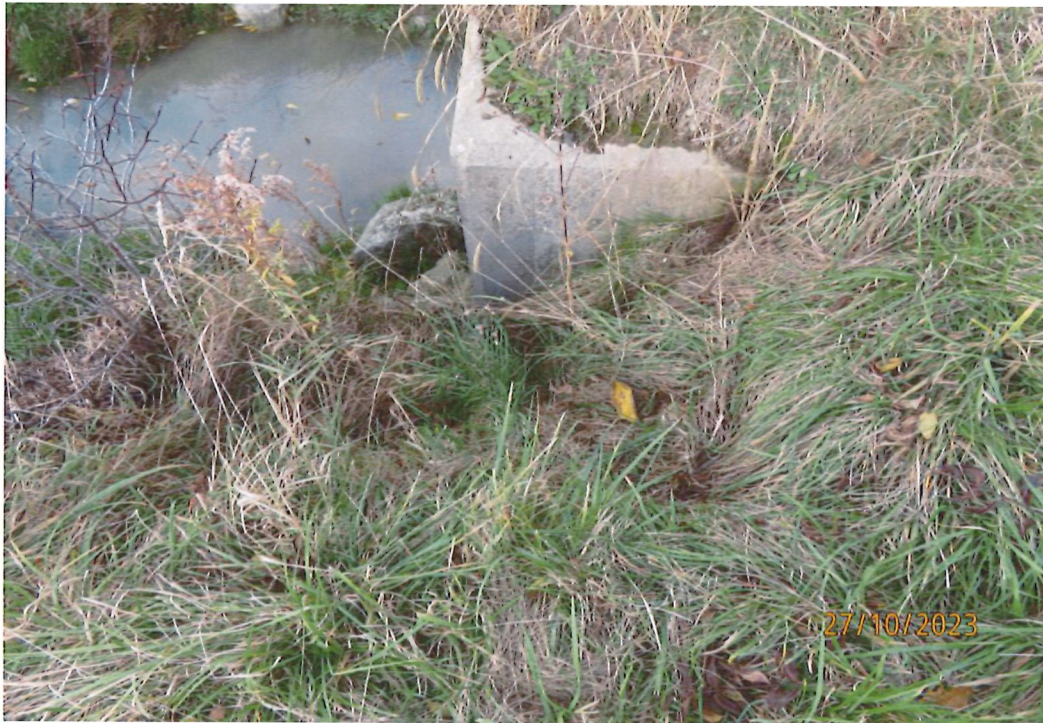
View of Erosion on Northwest Corner

Repair Rehabilitation Required		Priority			Estimated Construction Cost
Element	Repair and Rehabilitation Required	1 to 5 years	Within 1 year	Urgent	
Embankments	Erosion on northwest and southwest corners - repair	x			13000
Total Cost					\$13,000

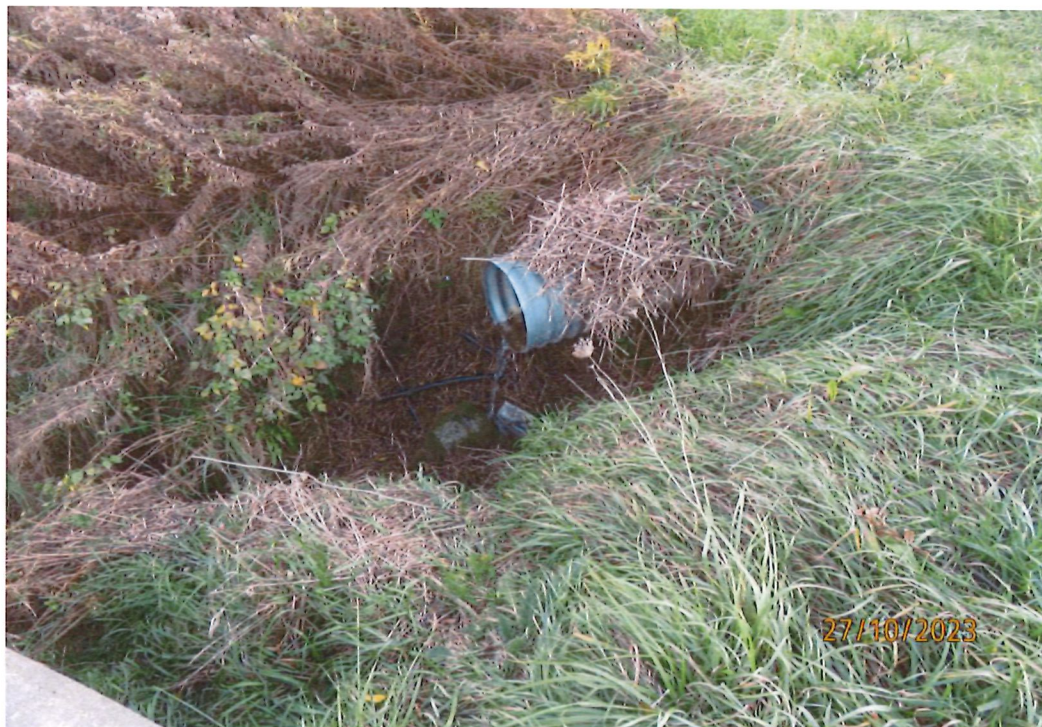
View of Erosion on Southwest Corner

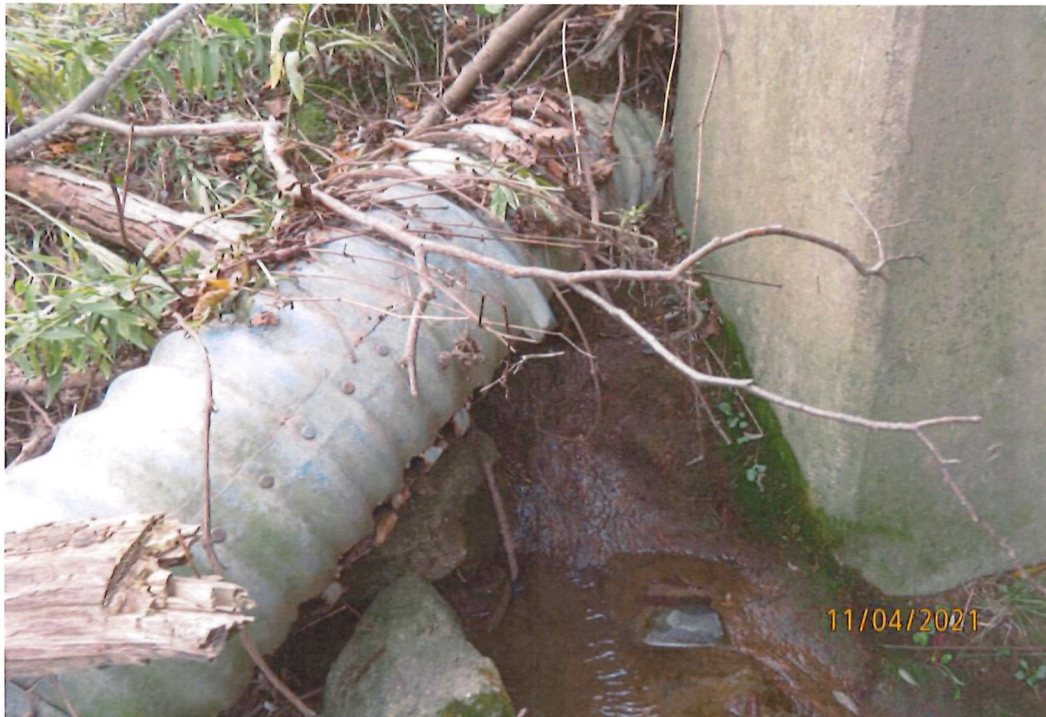
View of Rusting Outlet Pipe in Southwest Corner - File Photo

Element Group:	Embankments & Streams		Length:		
Element Name:	Embankments		Width:		
Location:			Height:	3.1	
Material:	Earth		Count:		
Element Type:			Total Quantity:		
Environment:			Not Inspected:		
Protection System:					
Condition	Units	Exc.	Good	Fair	Poor
Data:	sq. m / m / each / % / all			all	
Comments:					
Outlet pipe is rusting.					
Recommended Work:					
None: <input type="text"/> 1 - 5 years <input checked="" type="text"/> <1 year <input type="text"/>					
Urgent: <input type="text"/>					
Replace rusting outlet pipe.

Repair Rehabilitation Required		Priority			Estimated Construction Cost
Element	Repair and Rehabilitation Required	1 to 5 years	Within 1 year	Urgent	
Barrel	Repair concrete deterioration	x			10000
Embakments	Outlet pipe is rusting and should be replaced	x			7000
Total Cost					\$17,000

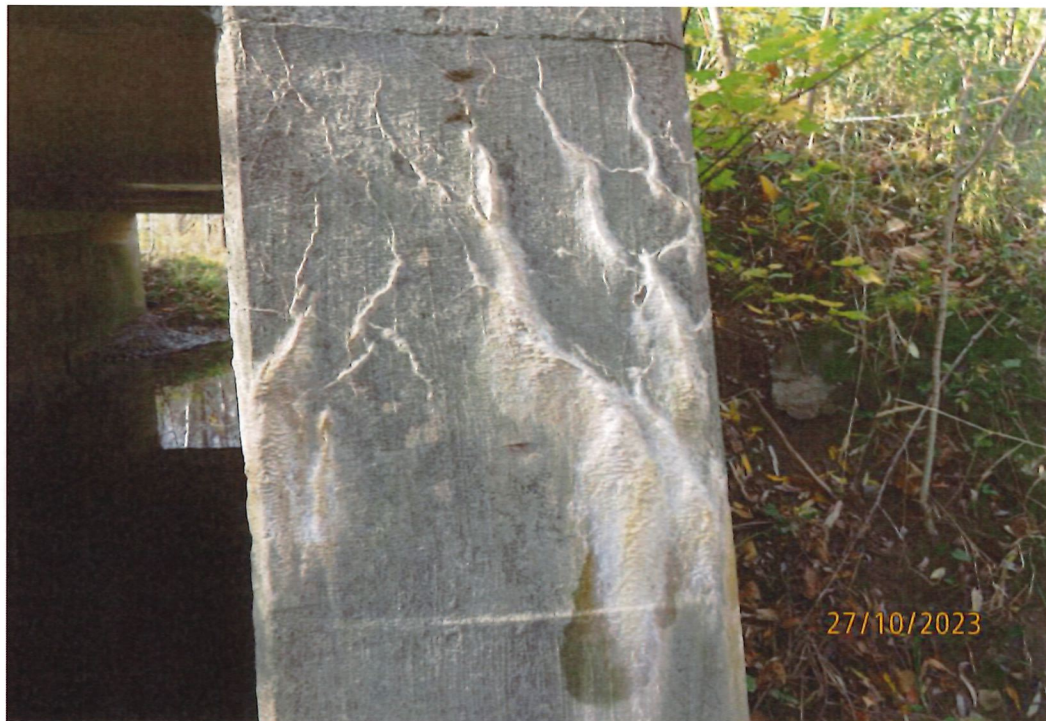
Efflorescence on Northeast Corner

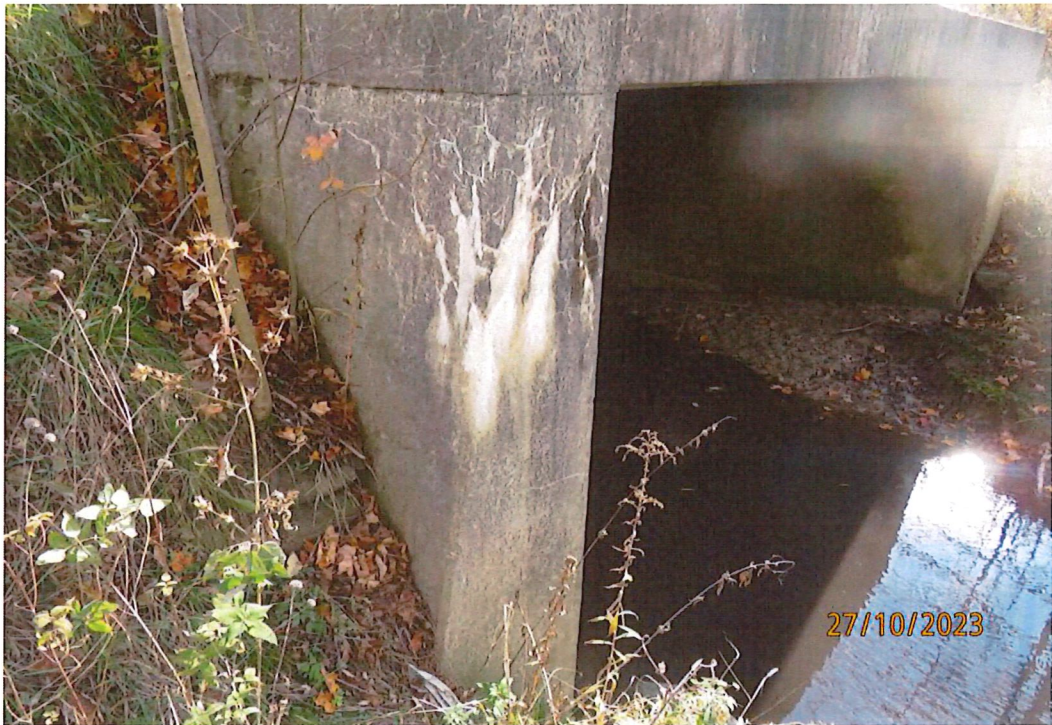
Efflorescence on Southwest Corner

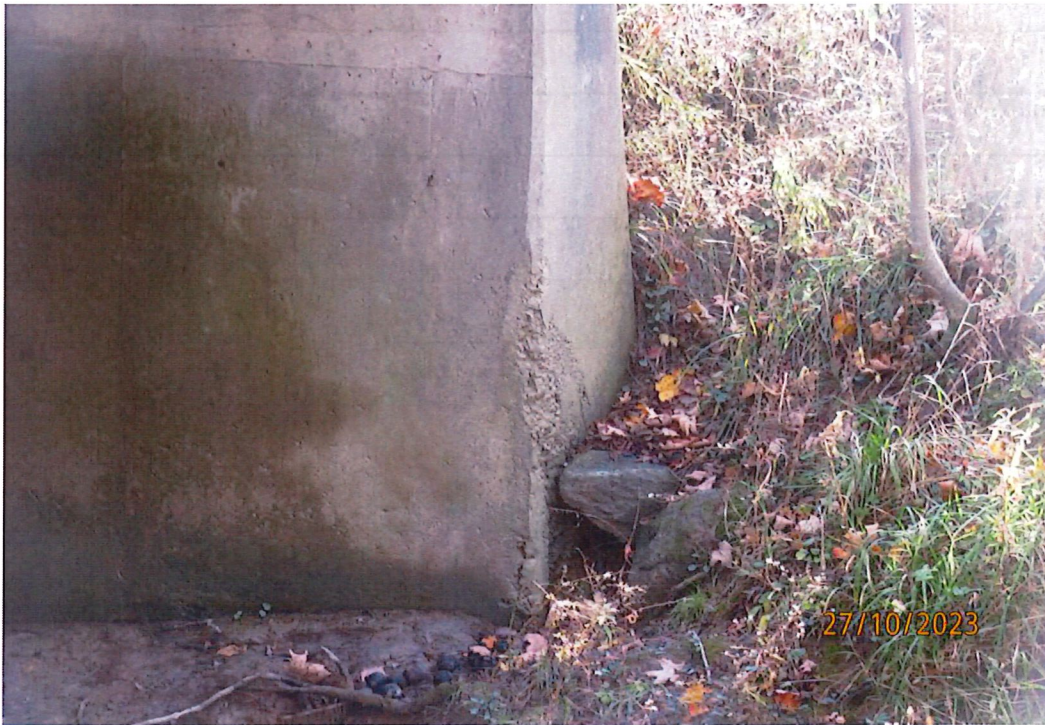
Concrete Deterioration on Southeast Corner
