REPORT TO: Mayor and Members of Council
DATE: August 30, 2017
FROM: Jill Bellchamber-Glazier, CAO-Clerk
SUBJECT: Southwest Middlesex Landfills Update

Solid Non-Hazardous Waste Disposal Site Inspection Report

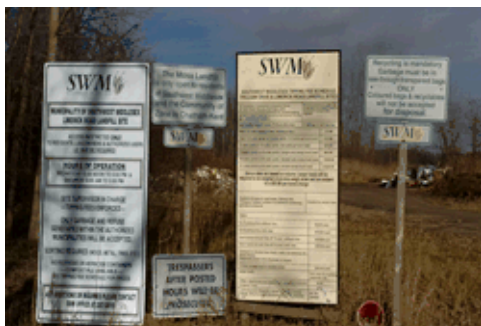
The site is fenced and secured by a gate. When open, the site is supervised by a municipal staff member. Signage at the entrance includes hours of operations, approved and unapproved wastes, tipping fees and contact information for the Municipality.

Signage at the landfill entrance
