FINAL REPORT

Limerick Landfill Closure Plan

724 Limerick Road, Bothwell, Municipality of Southwest Middlesex

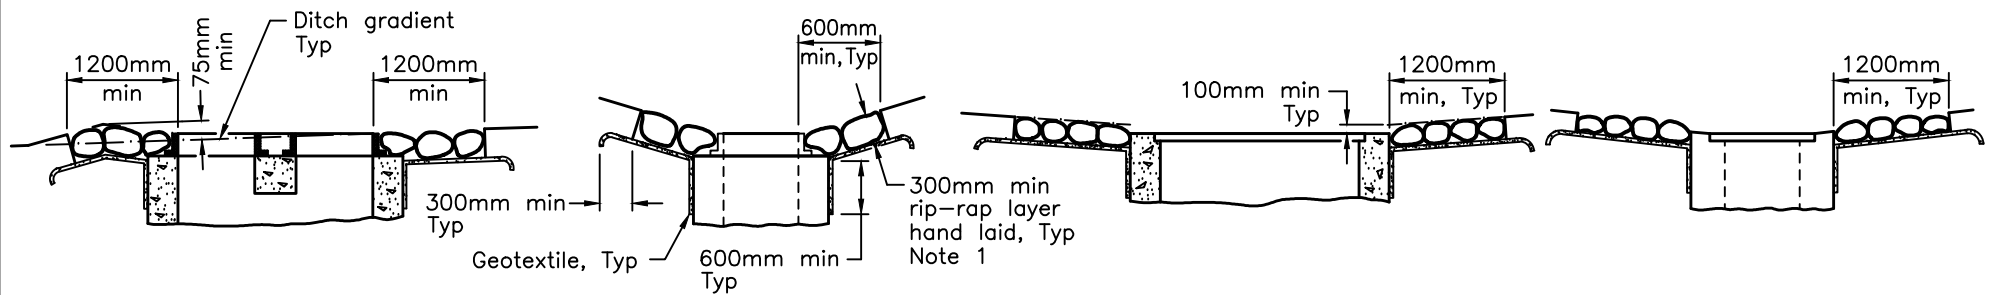
Ditch Longitudinal Section
Ditch Cross-Section
TWIN INLET-INTERMEDIATE

NOTES:
 1 The thickness of the rip-rap layer shall be at least 1.5 times the rip-rap mean diameter.
 A All dimensions are in millimetres unless otherwise shown.

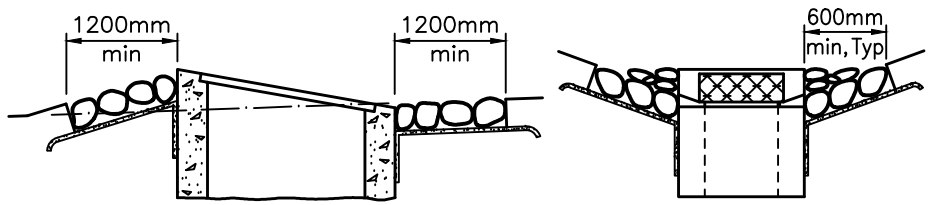
Ditch Longitudinal Section
Ditch Cross-Section
SINGLE INLET-INTERMEDIATE

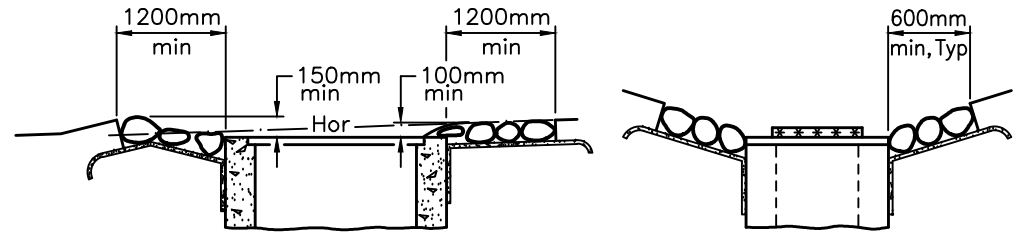
Ditch Longitudinal Section
Ditch Cross-Section
SINGLE INLET-INTERMEDIATE

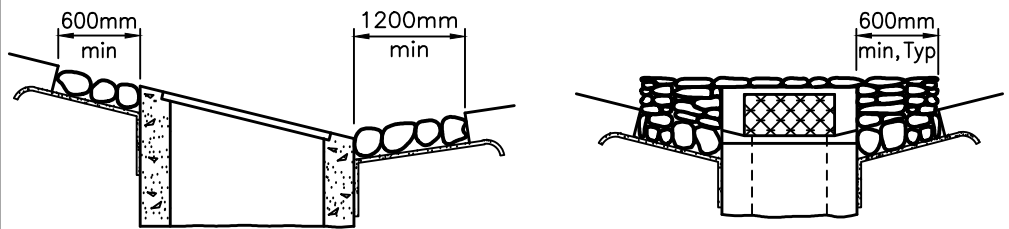
Ditch Longitudinal Section
Ditch Cross-Section
SINGLE INLET-END OF DITCH

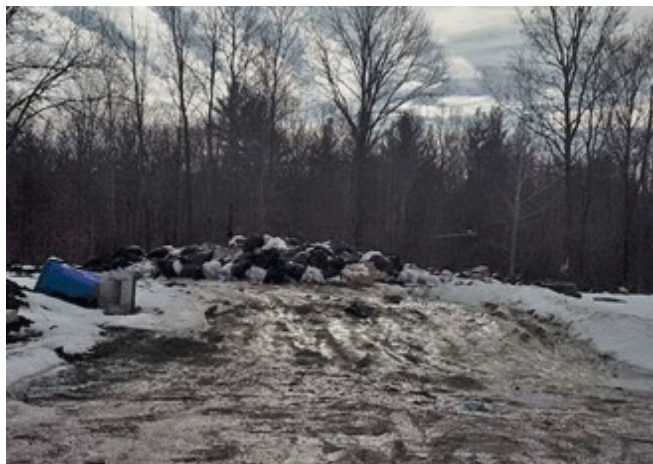
Active waste cell during inspection

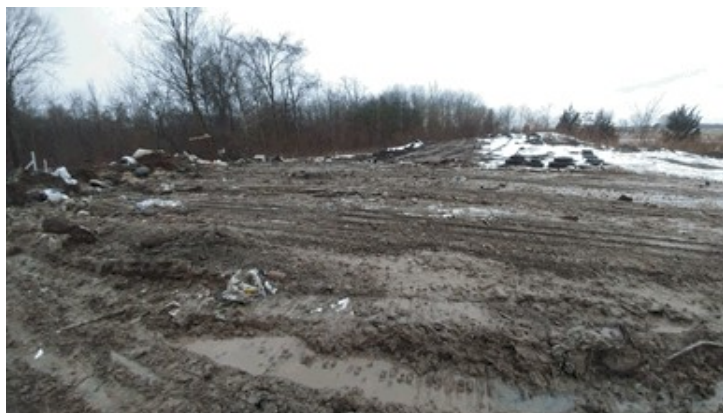
Active waste cell later that afternoon (pushed and covered). Picture taken and sent by Mr. Sholdice

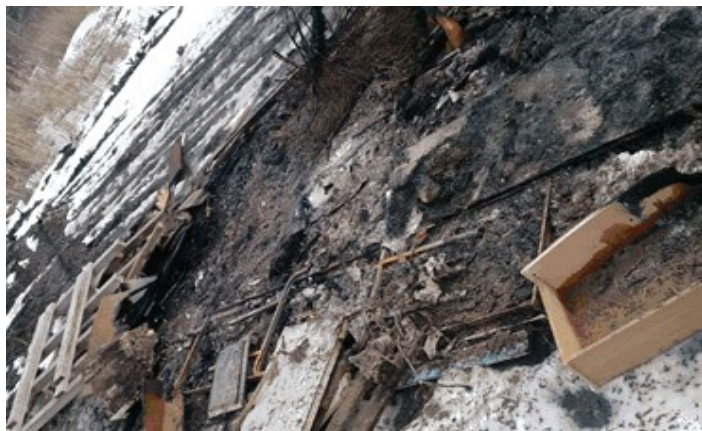
Evidence of burning.

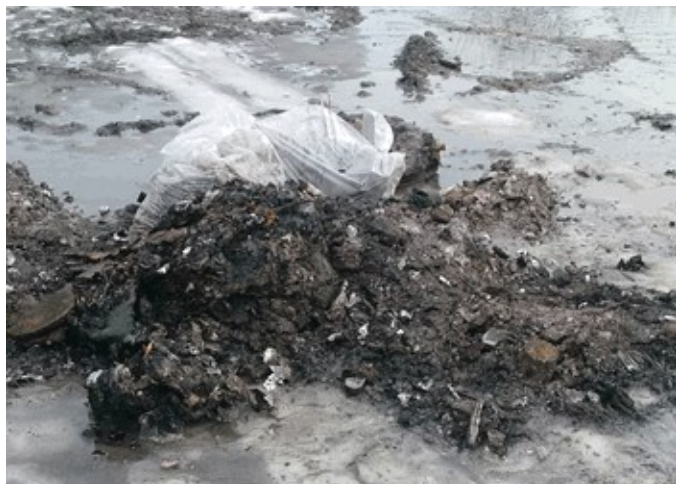
Mr. Sholdice stated that these plastic bags contained only weeds, ashes and pine tree needles, and that the burn pile in this picture are ashes dumped from barrels brought by residents.
